APOLLO 15 MISSION REPORT

MANNED SPACECRAFT CENTER  
HOUSTON, TEXAS  
DECEMBER 1971

Mission Evaluation Team

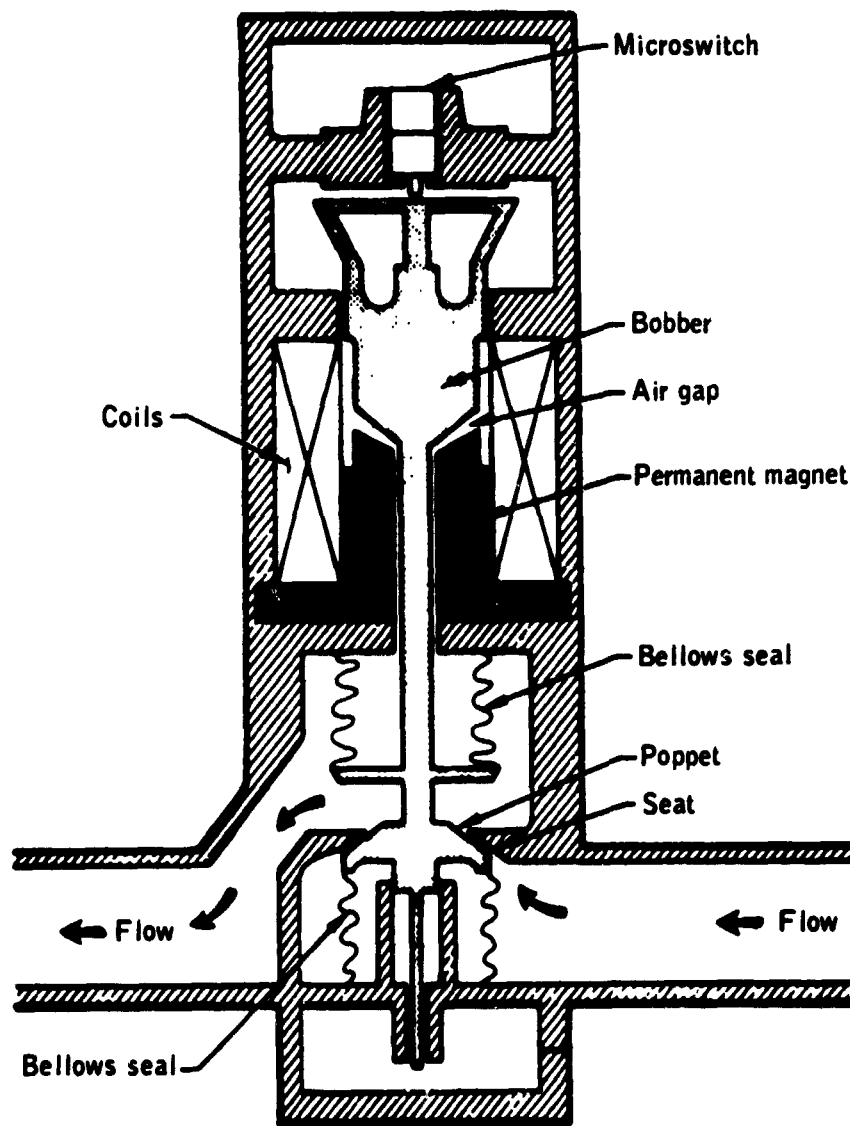
During acceptance testing of one valve for command and service module 117, the latching voltage had changed from approximately 13 volts to 3 volts. Additional testing of the spacecraft 117 valve verified the low voltage condition. Additionally, the valve stroke was proper, thereby eliminating contamination as a possible cause of the problem. During the test, the valve was disconnected from spacecraft power (28 volts) and was being supplied power through a variable power supply (approximately 20 volts, maximum, applied to the valve). The valve was most likely subjected to a reversed

Figure 14-1.- Cross section of reaction control system isolation valve.

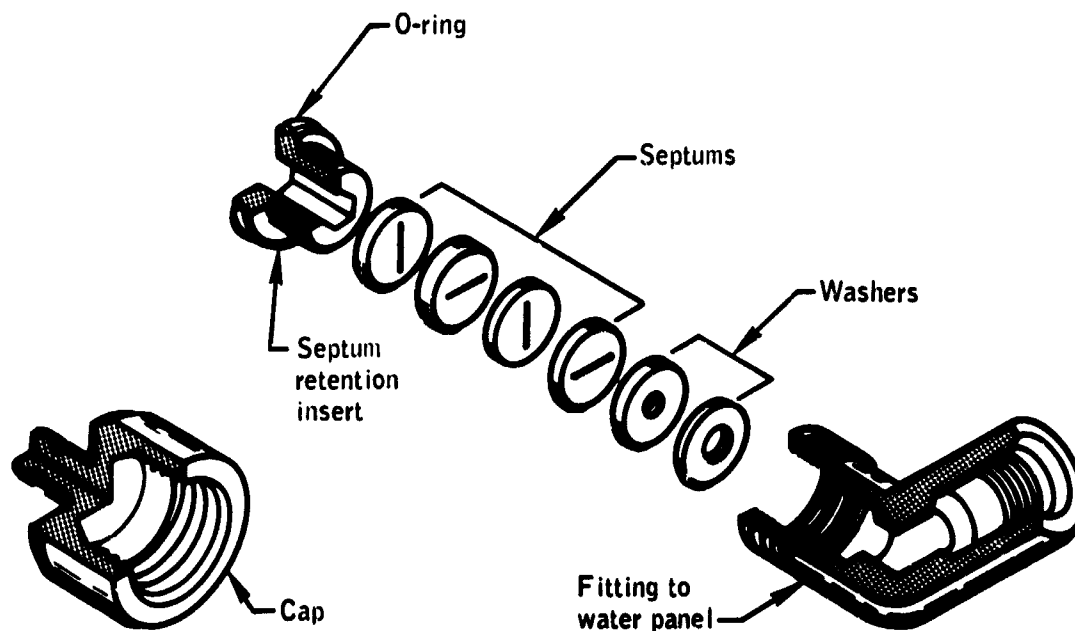
Postflight inspection and dimensional checks of the injection port assembly showed that all components were within established tolerances.

Figure 14-2.- Water panel chlorine injection port.

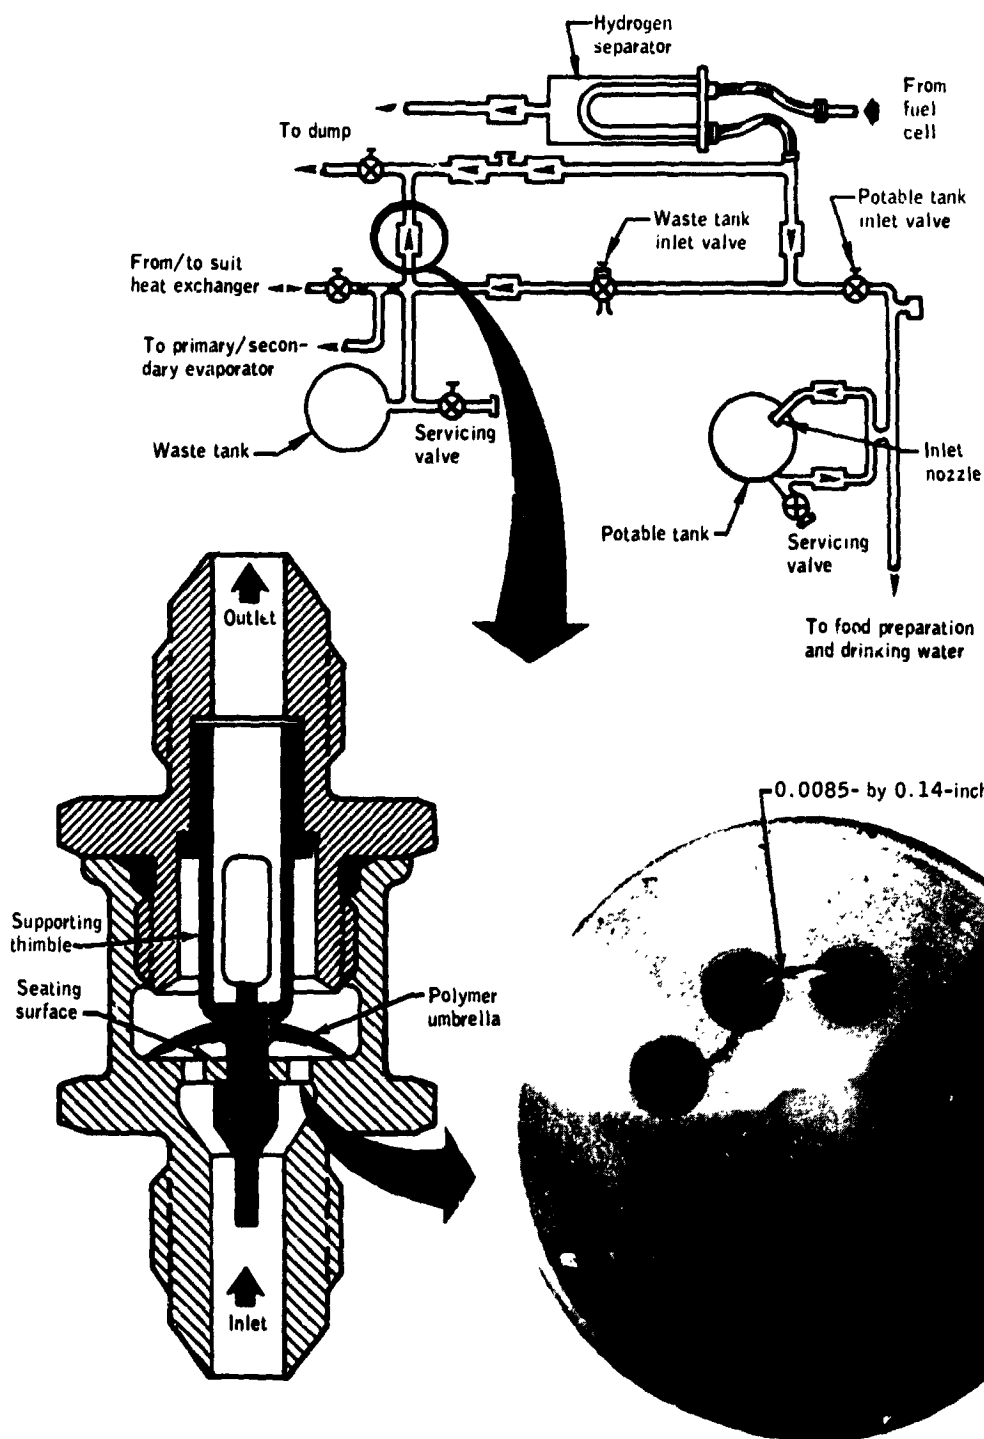
Figure 14-9.- Water management system and failed check valve details.

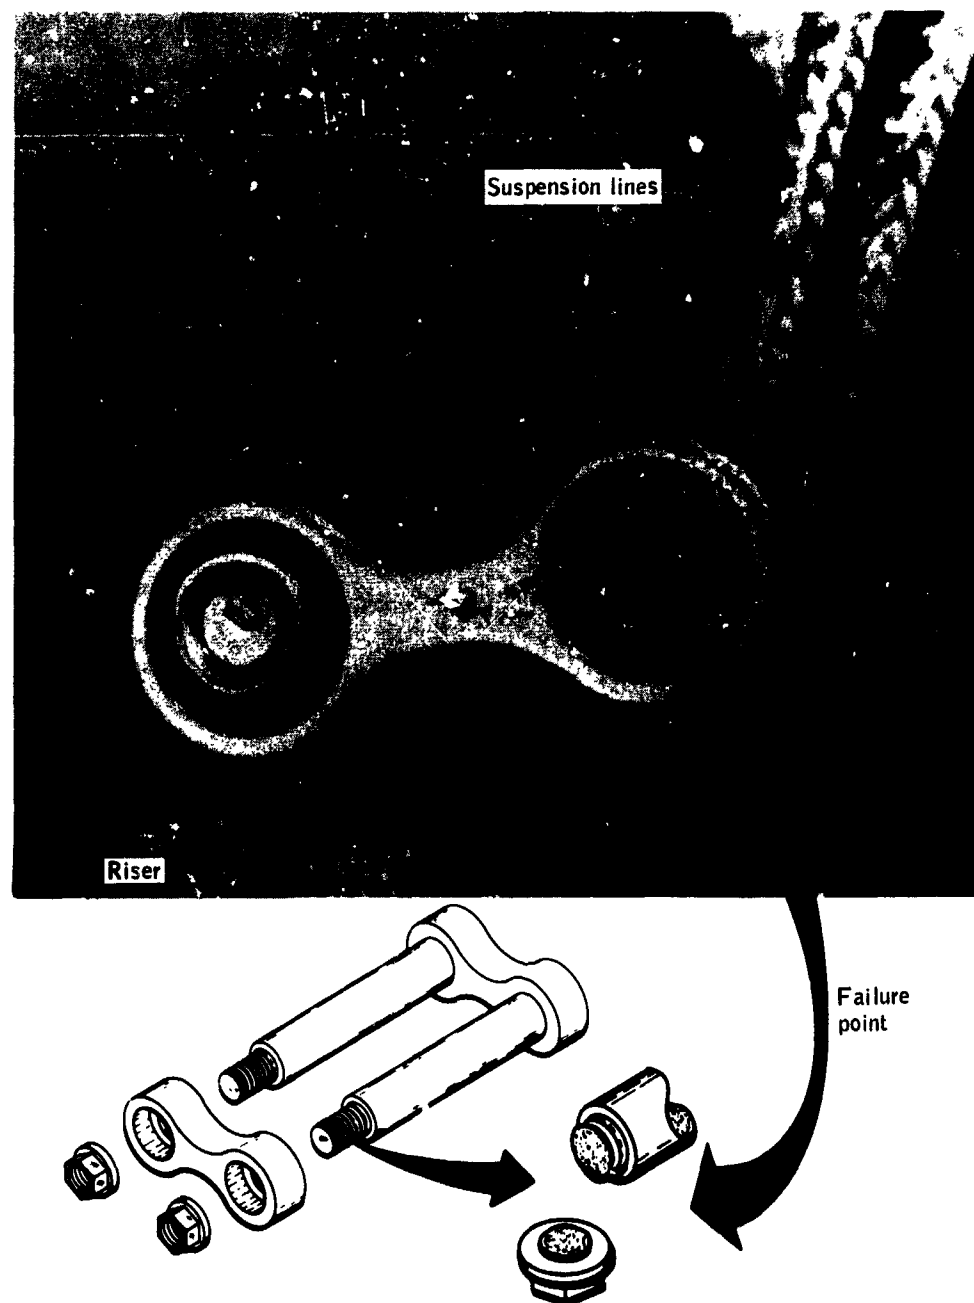
Figure 14-12.- Main parachute connector link failure.

In order to eliminate critical processing operations from manufacture of the connector links, the material was changed from 4130 to Inconel 718.

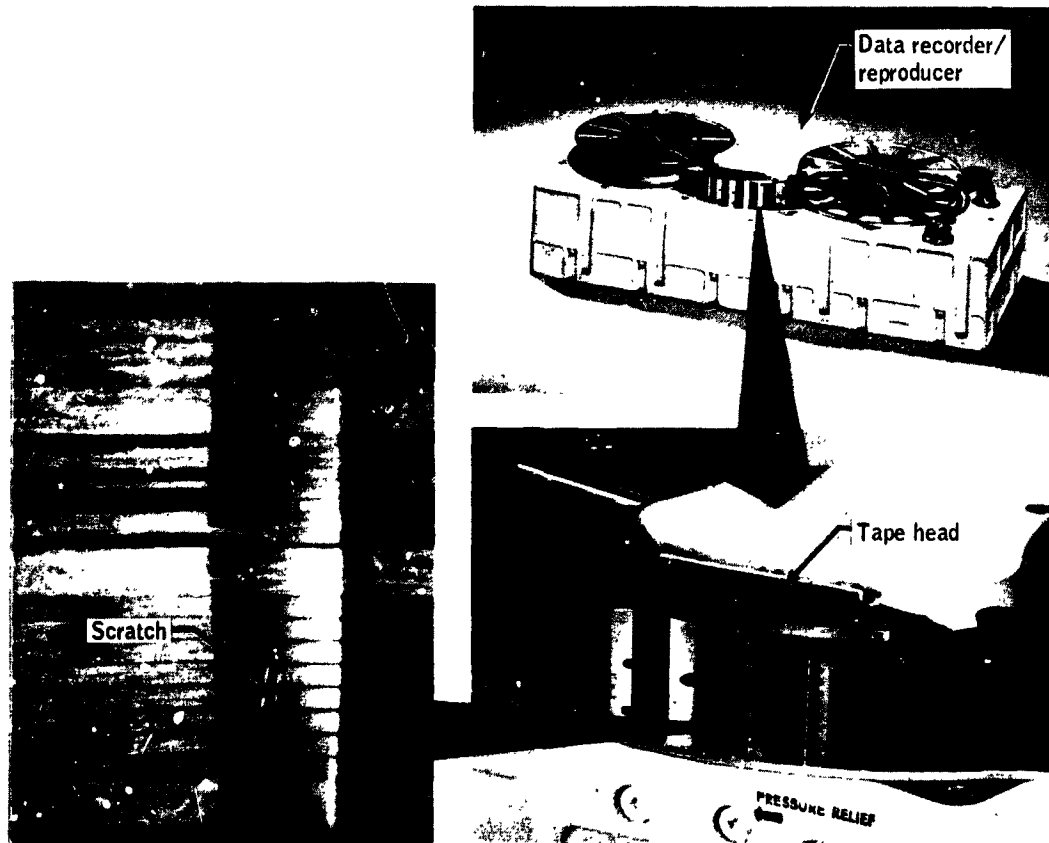
Figure 14-15.- Data recorder/reproducer and scratches on head.

Removable head covers have been provided to protect the heads from handling damage when the recorder covers are not installed. These covers have been used since early in the buildup cycle of the Apollo 16 and 17

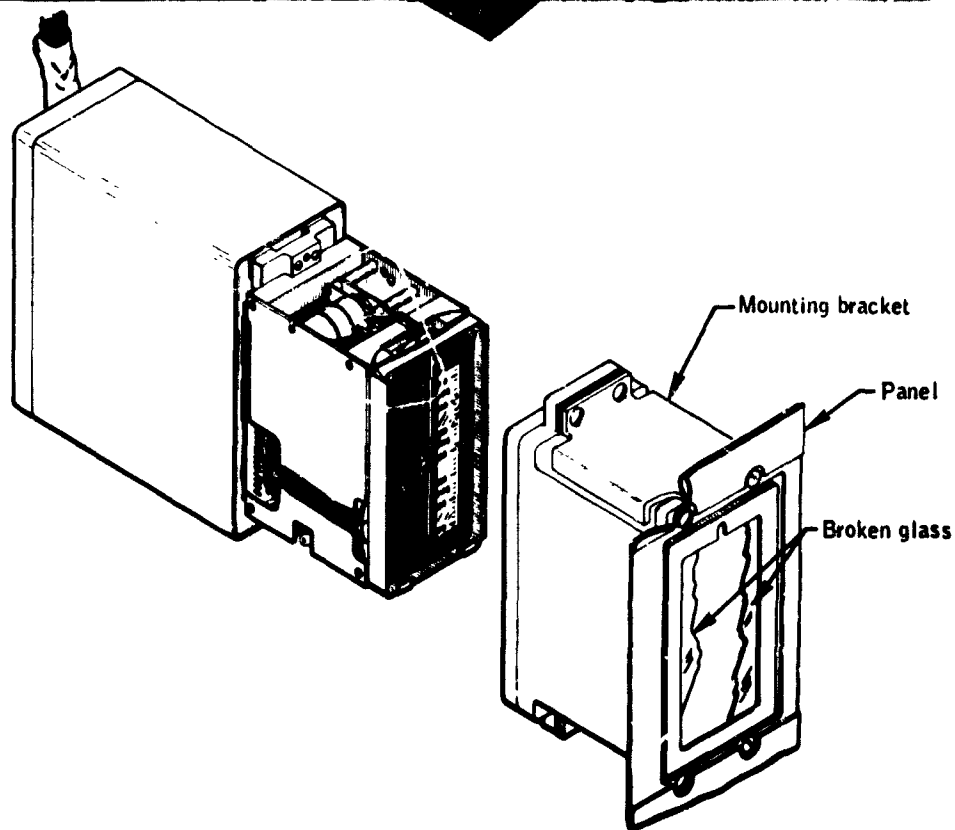
Figure 14-34.- Range/range rate meter mounting.

For future missions, an exterior glass doubler will be added to the window to reduce the maximum operating stress to less than 2000 psi. This will increase the threshold flaw depth to 0.0036 inch and the critical flaw depth to 0.032 inch. This should prevent future fatigue failures since there are no reported fatigue failures in soda-lime glass at stresses below 2000 psi. In addition, all similar glass applications in the lunar

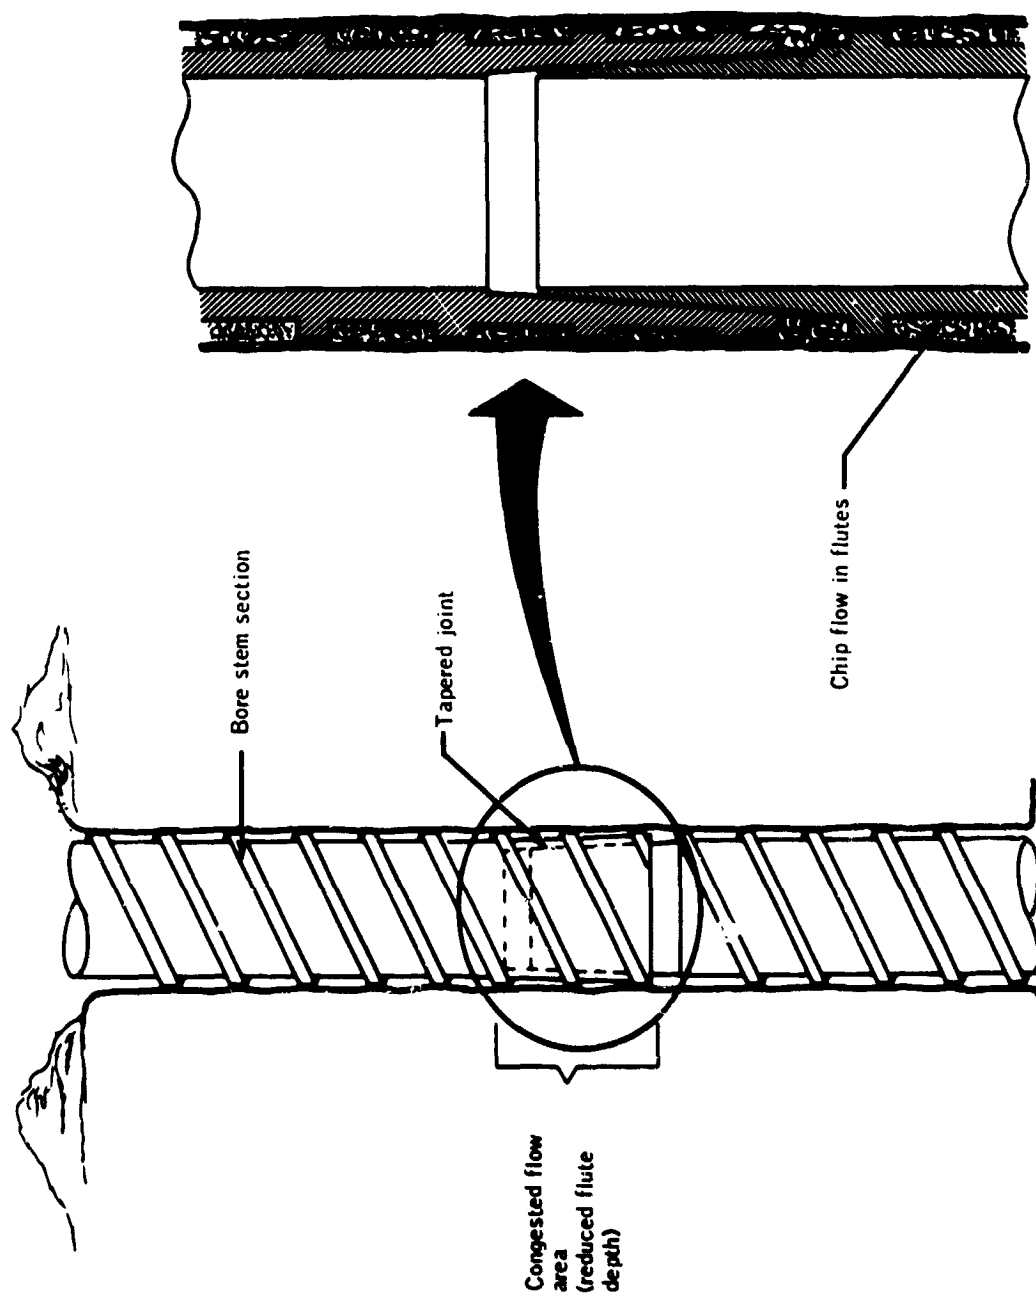
The performance of the drill power-head and the core stem was good. However, full depth penetration with the bore stems was a problem and extraction of the core stems from the hole was difficult (see sec. 14.4.1). The two bore stem holes were drilled to a depth of about 172 centimeters (70 inches) instead of the desired 294 centimeters (120 inches), with one of the bore stem strings probably sustaining damage at a point slightly above the first joint [about 105 centimeters (43 inches) below the surface] (see fig. 4-6).

Figure 14-41.- Congestion at bore stem joints.

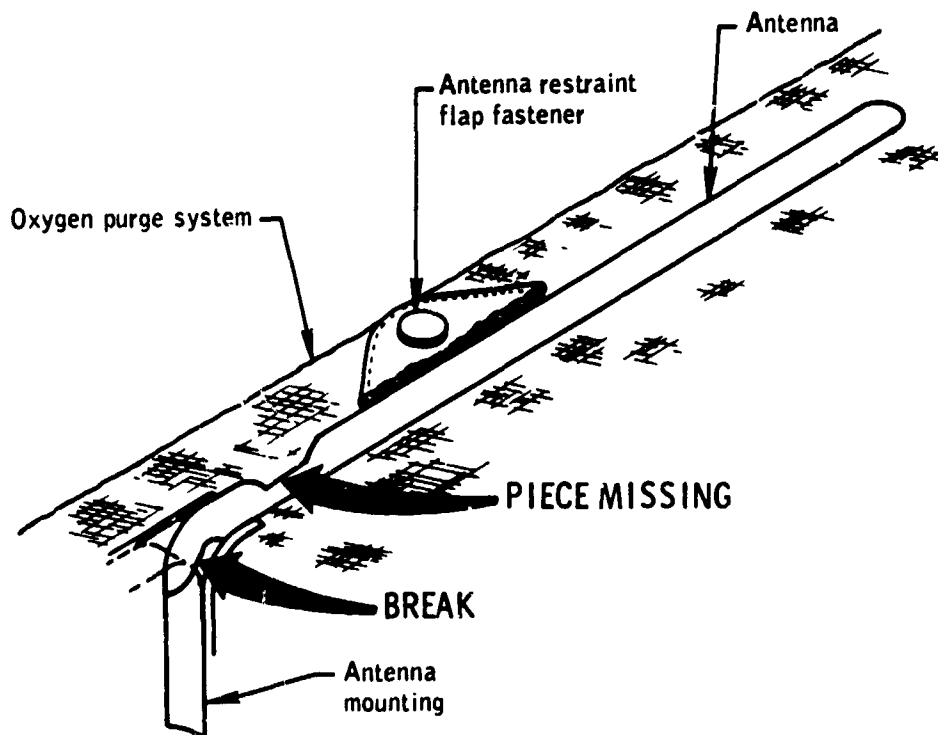
The communications check at the beginning of the second extravehicular activity was initially unsuccessful for the Lunar Module Pilot because his antenna was broken (sec. 14.5.6). The crewmen taped the antenna to the

Figure 14-51.- Damaged antenna stowed on oxygen purge system.

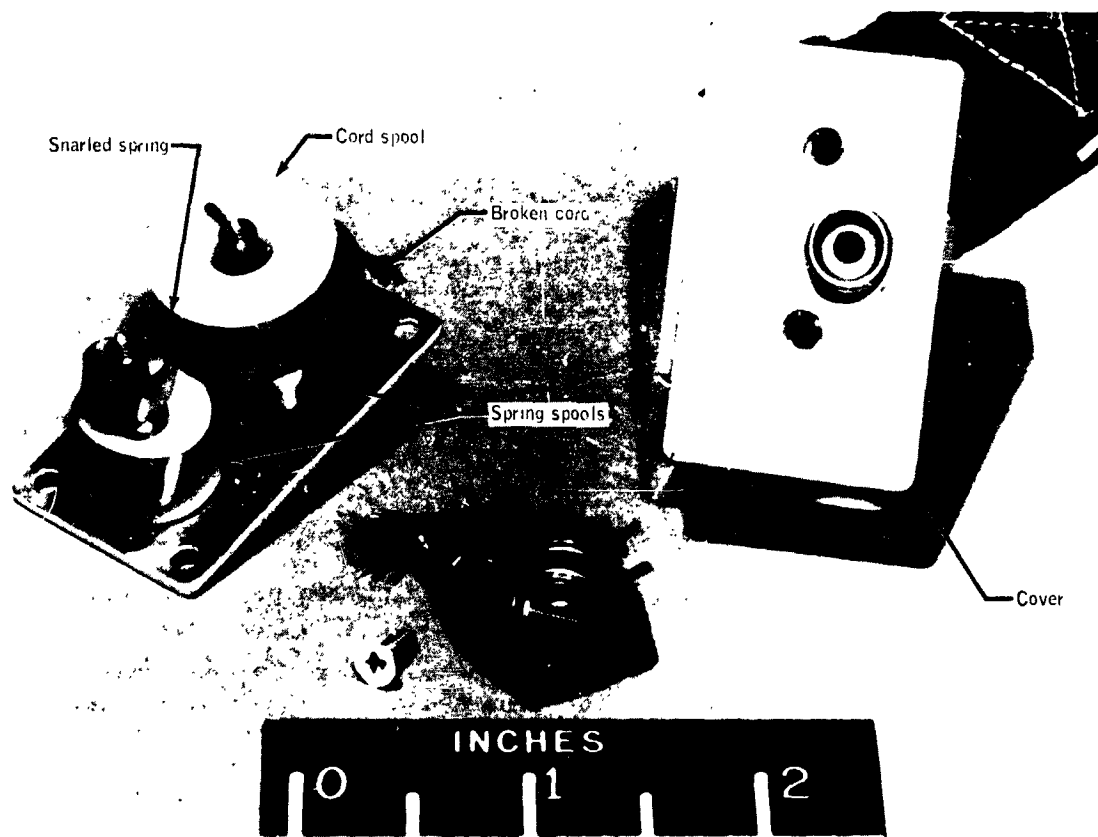
- f. Both retractable tethers (yo-yo's) failed (sec. 14.5.7).
- g. The tongs were difficult to operate during the third extravehicular activity; however, a backup pair was supplied for such a contingency and these operated satisfactorily.

Figure 14-52.- Commander's tether (cover removed).

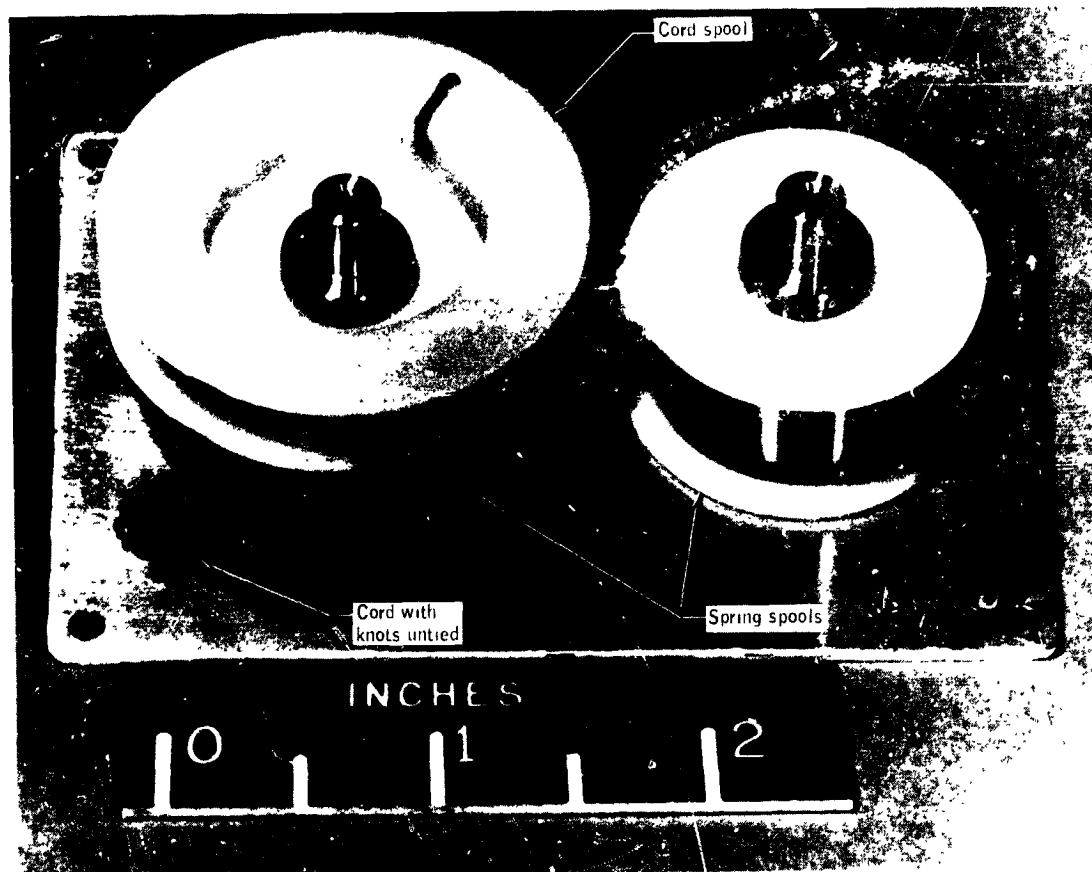
Figure 14-53.- Lunar Module Pilot's retractable tether (cover removed).
